**Wesley United Church**  
 Council Meeting in person  
 November 13, 2022  
 Minutes

This is a special meeting to discuss and consider a report on the state of the roof.

# Wesley Roofing Report

**Purpose:** To provide a summary of the condition of the roof, roof top chapel venting and the rooftop furnace units of Wesley United Church.

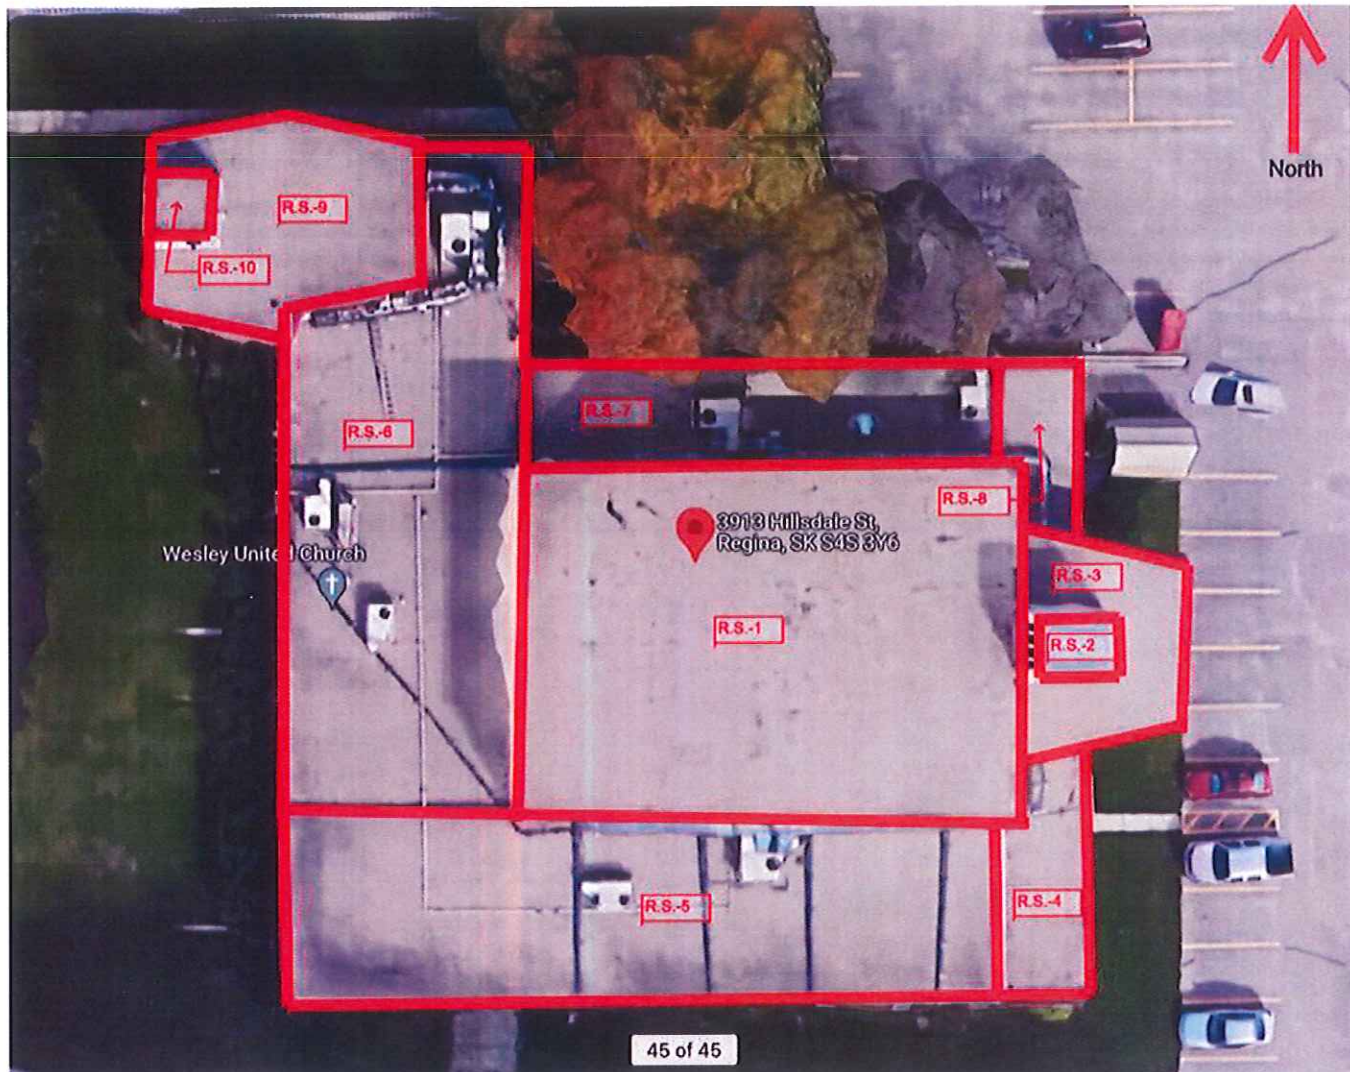
**a) *Roof Layout:*** The layout of the 10 different roof sections is illustrated below.

Roof Section Age	Condition	Appr. Size Remaining Life	Roof Type	Appr.
1 (Auditorium) 0		4,350 ft <sup>2</sup>	BUR	25+ Poor
2 (Chancel Tower) 5-10		100 ft <sup>2</sup>	SBS	5-10 Fair
3 (Chancel) 0		700 ft <sup>2</sup>	BUR	25+ Poor
4 (Choir & W Furnace Rm) 1-4		600 ft <sup>2</sup>	BUR	25+ Poor
5 (Rooms 105 to 107 & Hall) 0		3,750 ft <sup>2</sup>	BUR	25+ Poor
6 (Chapel Lounge to Rm 104) 0		3,500 ft <sup>2</sup>	BUR	25+ Poor

- **Roof sections 1, 3, 5, 6 and 8 are in poor condition and replacement of these sections should be considered in the near future** to prevent major failure of the system and stop the ongoing leakage into the facility. Severely deteriorated membrane, ridges, blisters in membrane, deteriorated stripping, splitting membrane and ongoing leakage were found on these roof sections.
- **Roof sections 4, 7, 9 and 10 are in poor condition and replacement of these sections within the next 5 years** should be considered to prevent the premature failure of the roof system. Deteriorated membrane, ridges, blisters in membrane and deteriorated stripping were found on these roof sections.
- **Roof section 2 in fair condition but shows signs of degranulation.**

There is considerable detail in the report to substantiate these ratings and comments and it should be mentioned that the sections rated the worst for membrane deterioration, water ponding and wet insulation are 1, 5 & 6. I would question the assessment severity for sections 3 & 8 as we have not had ongoing water leakage in those areas and membrane condition ratings were not as bad as sections 1, 5 & 6. This can also be supported by own visual inspection of the roof. In addition, section 3 had a \$10,493 renewal done in 2011.

- **Capital replacement of roof sections 1, 3, 5, 6 and 8 recommended in the near future.**
- **Capital replacement of roof sections 4, 7, 9 and 10 recommended within the next 5 years.**

**The estimated cost of replacement of roof sections 1 and 3-10 is \$593,750 +/- 25%. or a range of \$445,312 to \$742,187**
